AIRCRAFT ACCIDENT REPORT

ADOPTED: March 28, 1967**RELEASED:** April 4, 1967

AMERICAN FLYERS AIRLINE CORPORATION
L-188C, N183H,
NEAR ARDMORE MUNICIPAL AIRPORT
ARDMORE, OKLAHOMA
APRIL 22, 1966

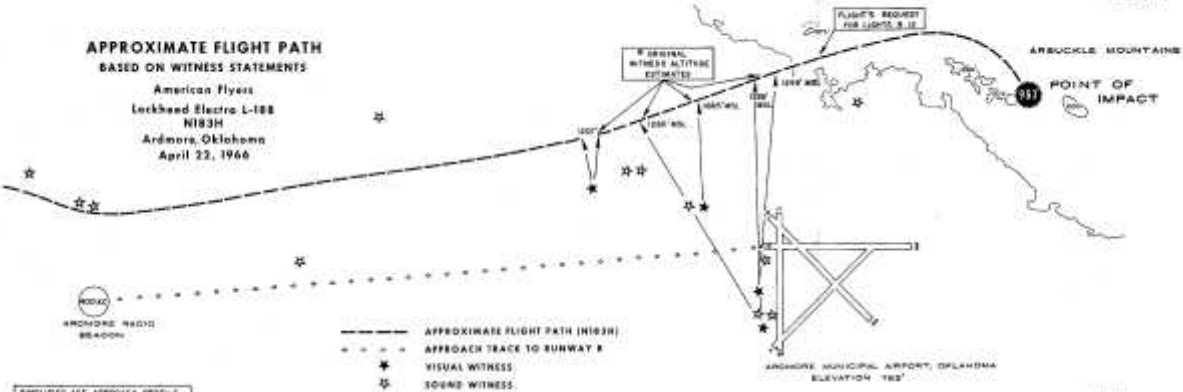
**APPROXIMATE FLIGHT PATH
BASED ON WITNESS STATEMENTS**

At 2026, Ardmore Radio requested Flight 280/D's position and was advised they were over the beacon inbound. According to ground witnesses who observed or heard the original flight and watched and/or listened to the fly-bys, the aircraft passed approximately one mile north of the beacon and turned to the northeast establishing a track of approximately 071 degrees magnetic.

11. After failing to complete the approach to runway 8, he flew north of the airport proceeding to an approach and landing on runway 30.
12. While attempting a right turn the captain experienced a coronary insufficiency and became incapable of controlling the aircraft causing the aircraft to descend rapidly towards the terrain.
